**ASHBY 'TOWN' CONSERVATION AREA
CHARACTER APPRAISAL**

**ADOPTED
AUGUST 2024**

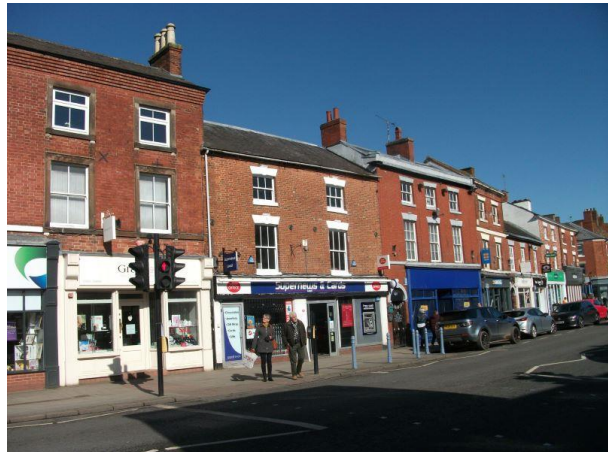
- 2.8.1. Generally buildings are arranged in terraced groups around a linear open space; some courtyard development survives. Generally buildings are three storeys tall. Most buildings are faced in red brick but a substantial minority are faced in render. The character zone contains 29 listed buildings.

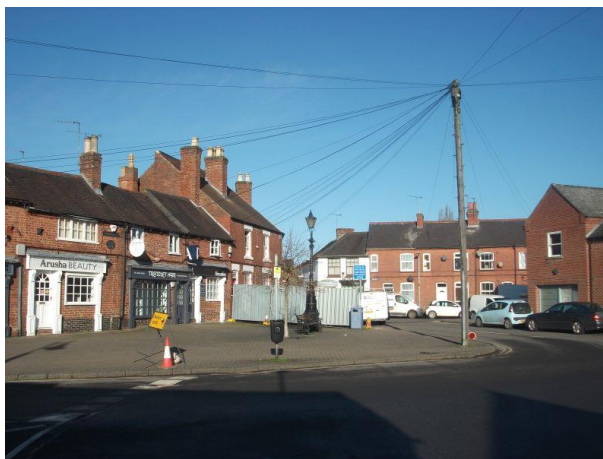
- 2.8.8. Generally buildings are arranged in terraced groups around an irregular open space (pictured right). Generally buildings are 1½ or 2 storeys tall. Generally buildings are faced in red brick. 8 to 12 The Green, 1 North Street and a former lamp standard are grade II listed buildings.

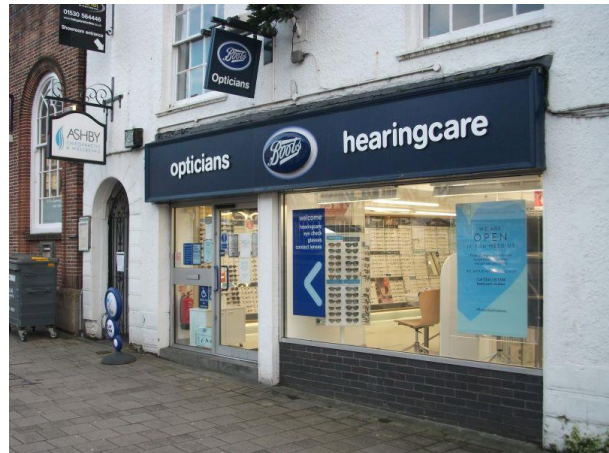
- Two listed buildings contain untreated aluminium shop fronts (52 Market Street (pictured); 63 Market Street).
